# Test Report

REPORT NUMBER:  
0306/792934

REQUISITIONER: Nordic Construction Solutions ApS  
N P Danmarksvej 93  
DK-8732 Hovedgård

SUBJECT: Two built-up walls, each measuring approx. 100 x 100 cm, have been supplied. A test specimen has been installed in each wall panel.

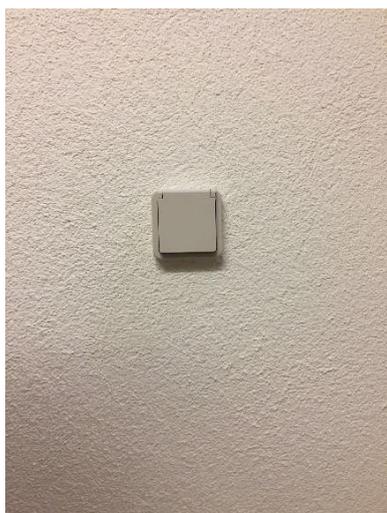
*Photo 1 - Specimen 1*

- Specimen 1      An LK Opus external power socket installed in the built-in outlet box. External dimensions are approx. 72 x 72 mm.
- Specimen 2      A metal ventilation grille. External measurement is Ø 120 mm.

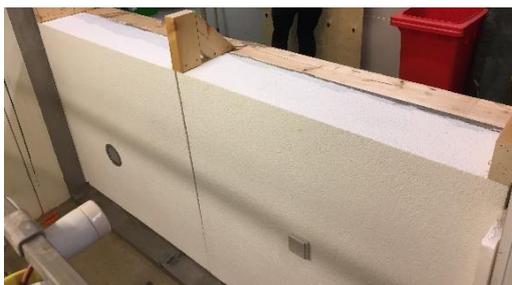
*Photo 3 - Specimens from exposed side*

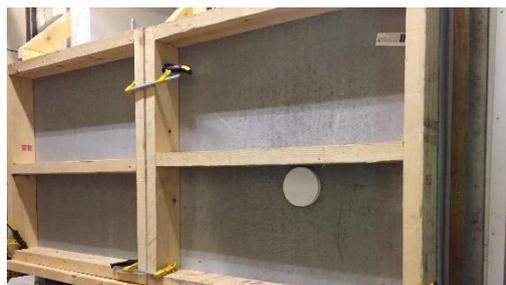
*Photo 4 - Specimens from non-exposed side*

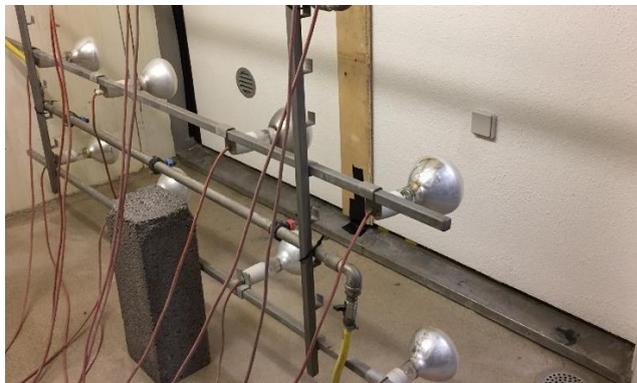
*Photo 5 – Specimens during set-up for climate ageing test*

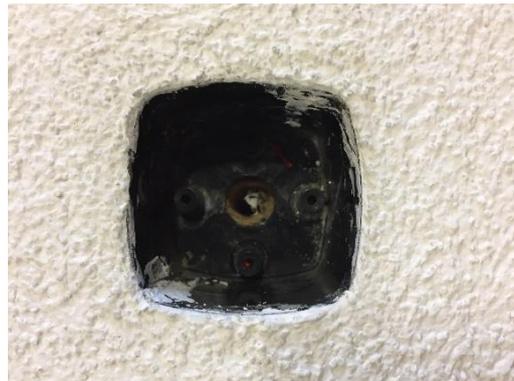
The outlet box behind it shows no immediate damage after testing, and no damage is seen on the rendered area around the socket. See Photo 7.

*Photo 7 – Built-in socket and transition to wall – after test*

It is believed that the twist of the external part (liner) is due to the transition between the screw in the liner and the thread in the outlet box.

It is believed that the fitting of the socket itself is OK and that the rendered part around the socket has not been damaged by the test.
