ATG Profile ApS

SMART MP

ETAG 004 pkt. 5.1.3.2.2 Freeze-thaw behaviour

Report no.: 872659-A

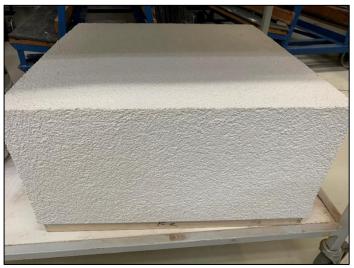
Three similar rendered boxes, with white render. The dimensions of the specimens are measured to $50 \times 50 \times 40$ cm. The specimens have "SMART MP" build-in, see drawing in appendix 1. The edges are rendered too, to avoid moisture in the inner insulation part.

Specimen (TI, 2019)

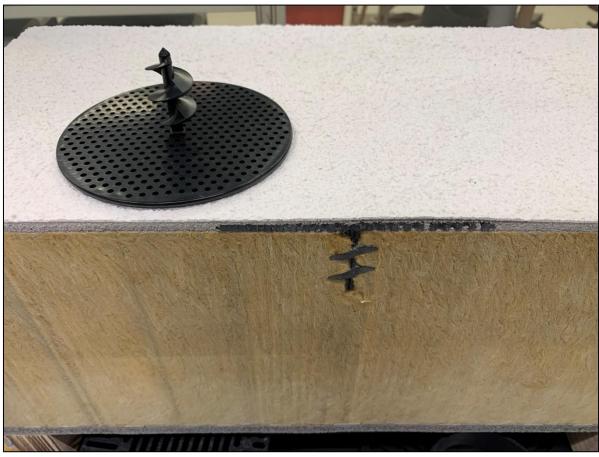
There was no visual damage (cracks, slips etc.)

Specimen cut over after test. New SMART MP to compare (TI, 2019)

Result: No visual damages were observed after the test.

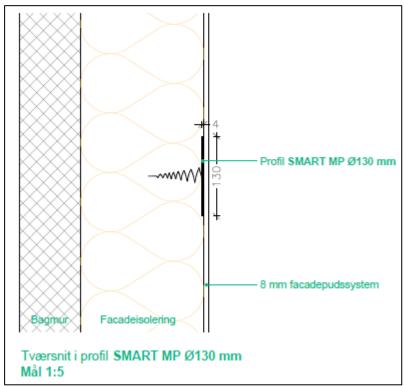
Drawing 1 Opbygning - ATG Profile ApS, 2019

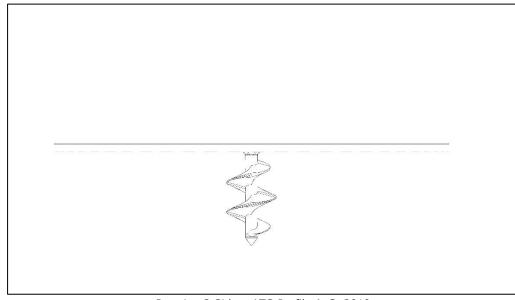
Drawing 2 Side - ATG Profile ApS, 2019

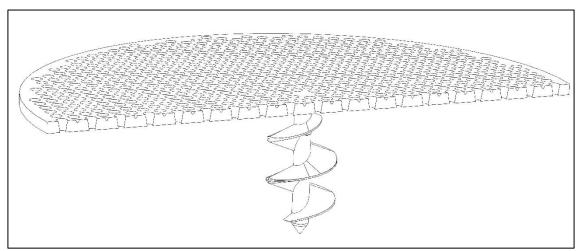
Drawing 3 Gennemskåret - ATG Profile ApS, 2019

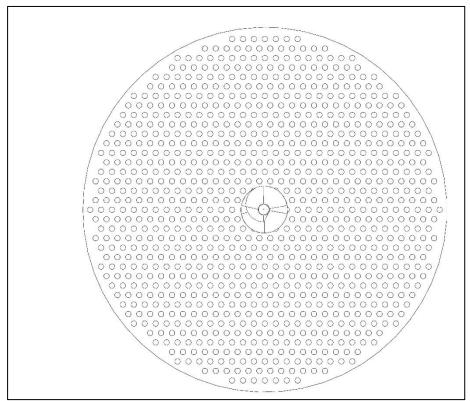
Drawing 4 Bund - ATG Profile ApS, 2019

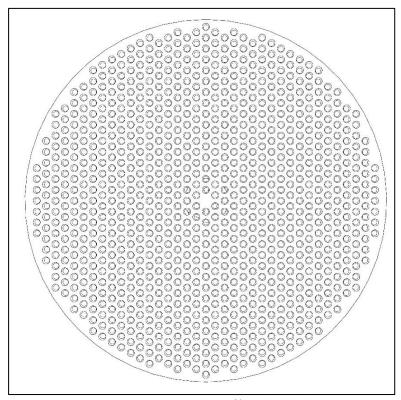
Drawing 5 Top - ATG Profile ApS, 2019
