# Test Report

REPORT NUMBER:  
816923

SUBJECT: Three built-up rendered wall panels. A test specimen (drain supports) has been installed in each wall panel.

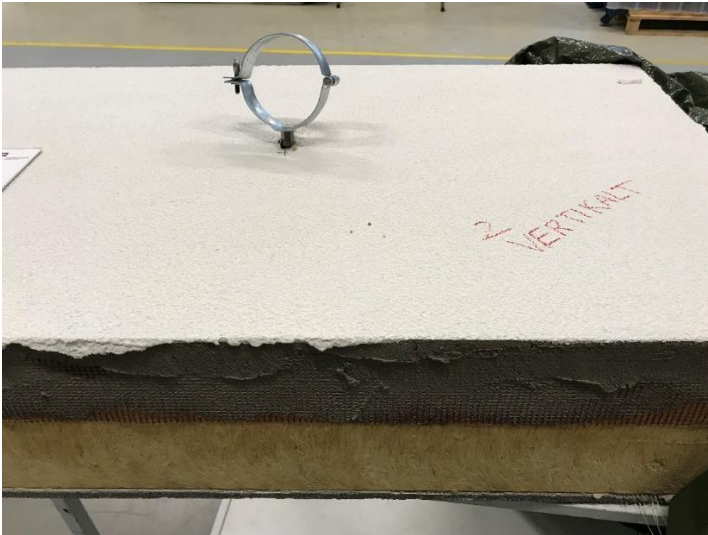
Photo 1 – Example of wall structure

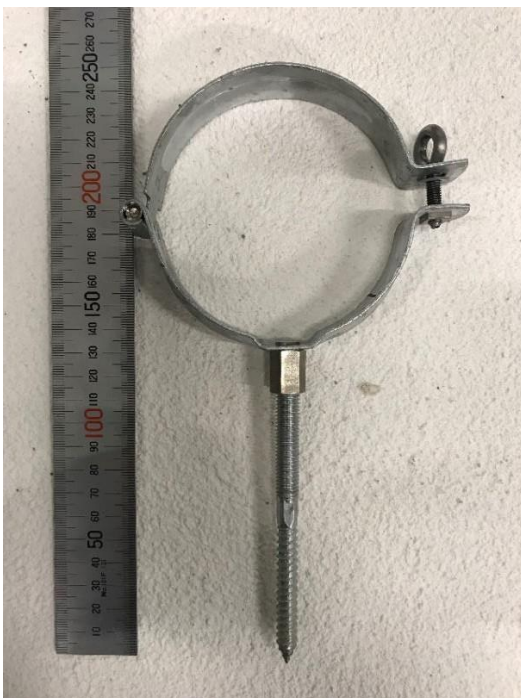
Photo 2 – Brackets used for Specimens 1+2

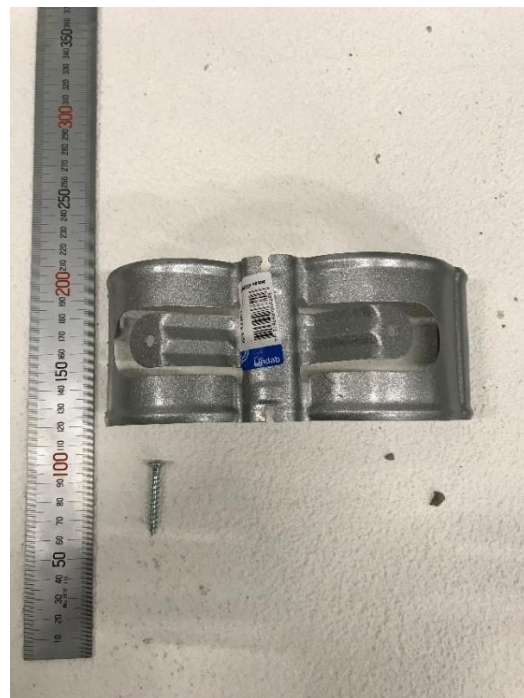
Photo 3 – Brackets used for Specimen 3

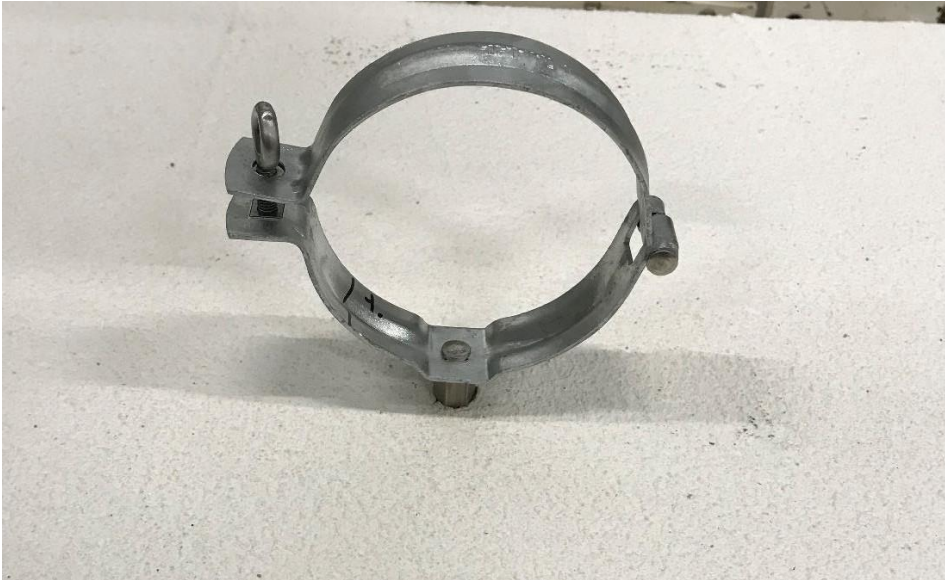
Photo 4 - Specimen 1 Before testing

A matrix was mounted on the test specimen (highlighted in red). The traction force was then measured with a load cell. Maximum recorded value = **1185 N**

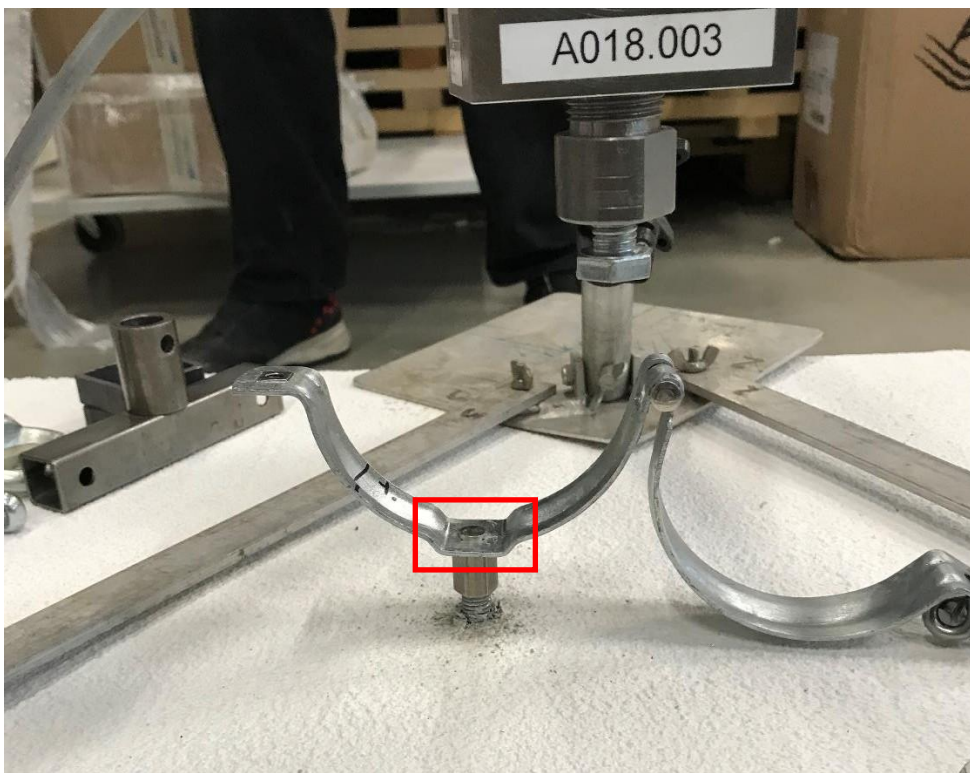
Photo 5 - Specimen 1 After testing

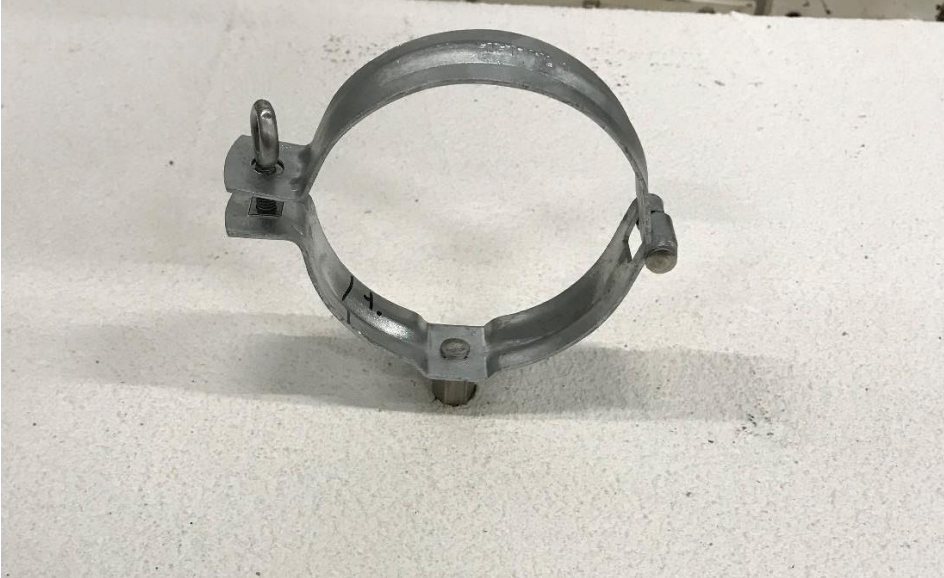
Photo 6 – Specimen 2 Before testing

The thread on the screw was pulled (highlighted in red). The traction force was measured with a load cell.

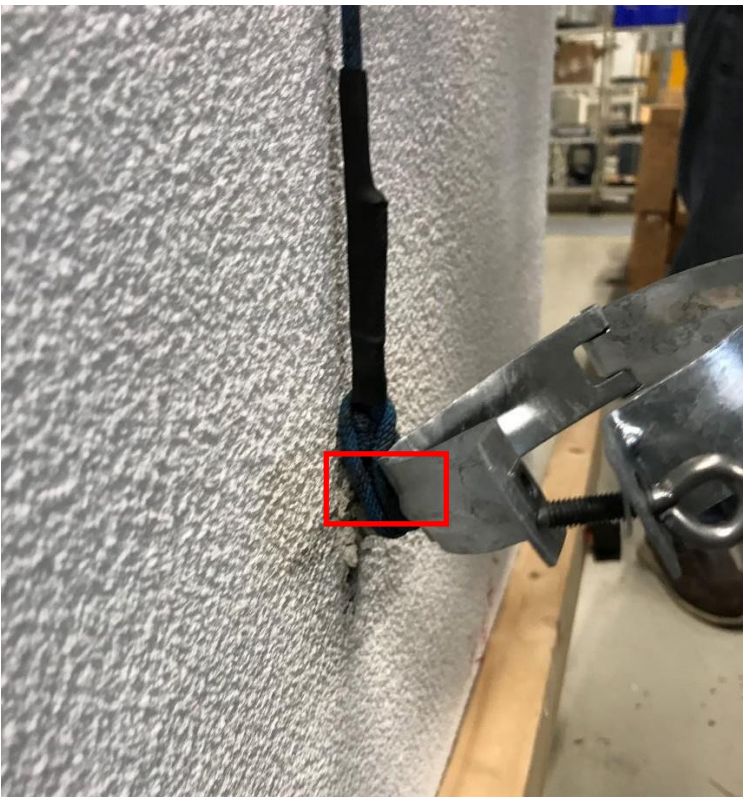
Photo 7 – Specimen 2 After testing

Maximum recorded value = **1194 N**

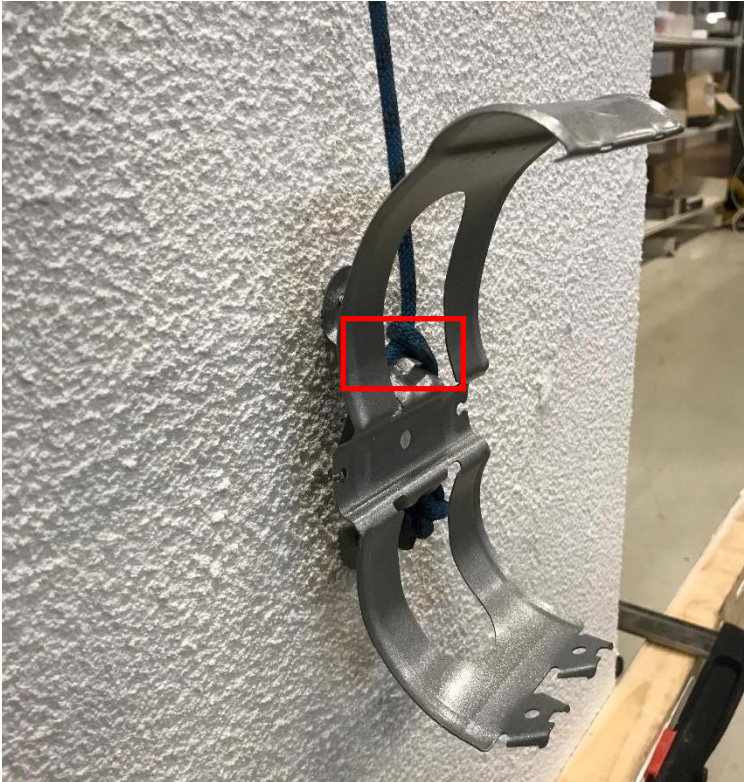
Photo 8 – Specimen 3 Before testing

The flange was pulled (highlighted in red) where one screw is mounted. The traction force was measured with a load cell.

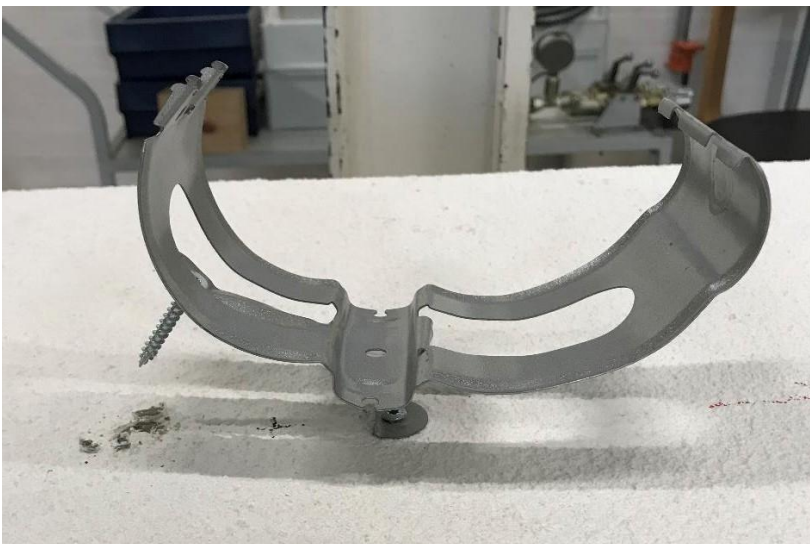
Photo 9 – Specimen 3 After testing

Maximum recorded value = **2009 N**
