SMART VP

ETAG 004 (2013)
Freeze-thaw pkt. 5.1.3.2.2

ETAG 004 pkt. 5.1.3.2.2 Freeze-thaw behaviour

Report no.: 872659-B-r1

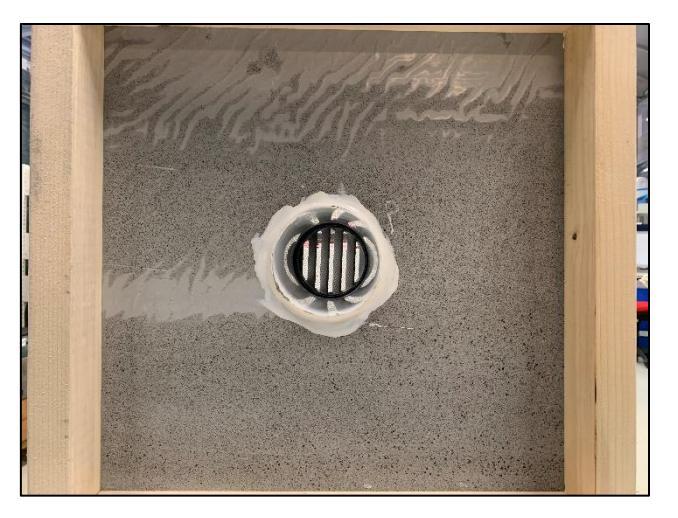
Photo 1 – Specimen from backside, DTI 2019

Three similar rendered boxes, with white render. The dimensions of the specimens are measured to 50 x 50 x 40 cm. The specimens have "SMART VP" build-in, see drawing in appendix 1. The edges are rendered too, to avoid moisture in the inner insulation part.

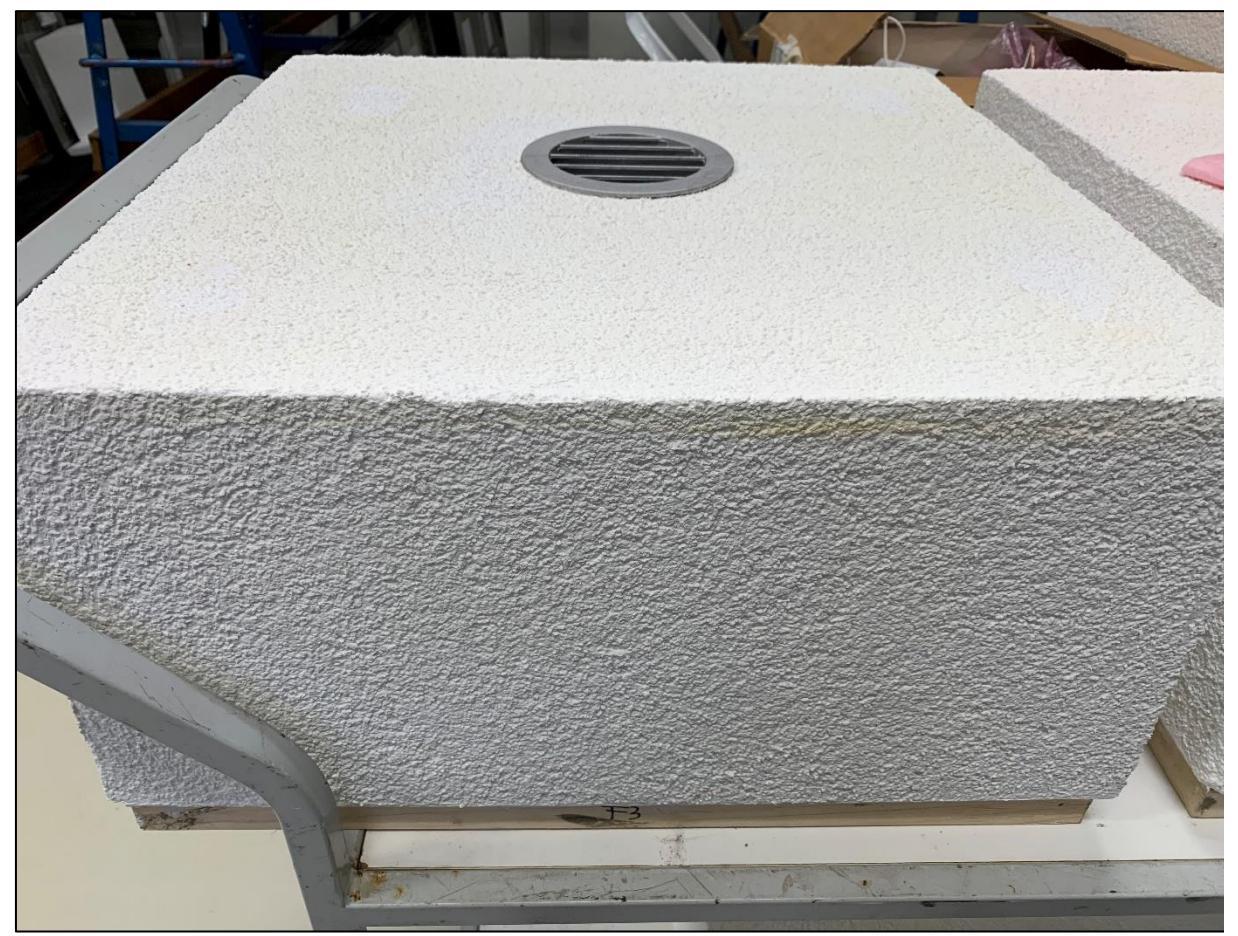
There was no visual damage (cracks, slips etc.)

Photo 2 - Specimen after test, DTI 2019

Result:	No visual damages were observed after the test. Results are given on page 6.		
Storage:	The sample will be destroyed after 2 months if nothing else has been agreed in writing.		
Remarks:	Revision 1. Frontpage picture changed.		
Terms:	The test has been performed according to the general terms and conditions of The Danish Technological Instit The results from DTI's work in this report, i.e. analyses, assessments and instructions may only be used or repor their entirety. The customer may not mention or refer to DTI or DTI's employees for advertising or marketing purposes unless the DTI has granted its written consent in each case.		
Location:	2019-12-20, Danish Technological Institute, Building & Construction, Aarhus
